WOOD DESTROYING PESTS AND ORGANISMS INSPECTION REPORT

BUILDING NO. 469	STREET, CITY, STATE, ZIP GREEN VIEW DRIVE, WALNUT CREEK, CA, 94596	COUNTY CODE 07	DATE OF INSPECTION 10/01/02	NUMBER OF PAGES 4
---------------------	---	-------------------	--------------------------------	----------------------

REGISTRATION # PR 1466	REPORT # 35200	STAMP #	ESCROW #
---------------------------	-------------------	---------	----------

ORIGINAL REPORT <input checked="" type="checkbox"/>	LIMITED REPORT <input checked="" type="checkbox"/>	SUPPLEMENTAL REPORT <input type="checkbox"/>	REINSPECTION REPORT <input type="checkbox"/>	*Original Stamp #	Date
GENERAL DESCRIPTION: <u>ONE STORY FRAME DWELLING</u>					
INSPECTION TAG POSTED: <u>GARAGE</u>					
OTHER INSPECTION TAGS: <u>TERMINIX</u>					
1. SUBSTRUCTURE AREA	SEE BELOW	See 1A			
2. STALL SHOWER	SEE BELOW	See 2A			
3. FOUNDATIONS	CONCRETE				
4. PORCHES -- STEPS	CONCRETE				
5. VENTILATION	APPEARS ADEQUATE				
6. ABUTMENTS	NONE				
7. ATTIC SPACES	NOT INSPECTED/SEE BELOW	See 7A	X	X	
8. GARAGES	SEE BELOW	See 8A	X	X	
9. DECKS -- PATIOS	EXCLUDED/SEE HEADING		X	X	
10. OTHER -- INTERIOR	SEE BELOW	See 10A-10C	X	X	
11. OTHER -- EXTERIOR	SEE BELOW	See

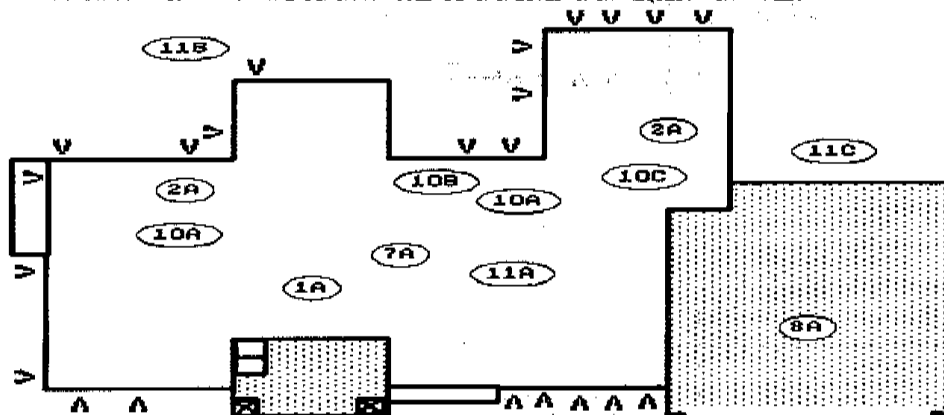
DIAGRAM AND EXPLANATION OF FINDINGS (This report is limited to structure or structures shown on diagram)

Item 1A: Scattered cellulose debris was noted throughout the substructure. At the time of this inspection we noted no wood destroying pest within the debris. Other firms apparently Terminix have this structure under the SENTRICOM SYSTEM as there are baiting stations around the perimeter. All information regarding the service contract or service intravels of this style of baiting system would need to come from that pest control firm under contract.

Item 2A: The master bathroom and guest bathroom shower stalls were both inspected and water tested. We noted no leaks directly affecting any wood members. There is the need of minor touch up grouting or caulking which should be done as part of normal property maintenance.

Item 7A: This is to be considered a limited inspection as attic area was not inspected. This inspector could not be certain that an attic inspection would not cause damage to finished ceilings. A further inspection of this area would be performed upon request and upon written release of any liability of possible damage that could occur to finished ceilings during the course of this inspection.

Item 8A: Interior of the garage was inaccessible due to excessive storage. A further inspection is recommended and would be made after all storage has been removed away from interior walls.

Item 10A: Hall bathroom vinyl was swollen. Underlayment appears to be somewhat soft adjacent to the plumbing end of the tub/shower. Tub/shower was water tested, there are stains below the plumbing area. However no active leaks affecting wood members. Vinyl flooring also appears to be slightly soft adjacent to the front of the guest bathroom shower stall. True conditions below the vinyl in these two locations could not be determined without defacement of vinyl floor covering. A further inspection below the vinyl is recommended and would be made upon request at additional charges.

Item 10B: There are some stains below the kitchen area. Hardwood flooring in front of the dishwasher is starting to split slightly. However we noted no infestation on accessible wood members. All information regarding the condition of the appliances would need to come from proper trades. Appliances are not tested, areas below the appliances are inaccessible. We would if requested perform a further inspection after it has been removed.
 ***** Unknown Further Inspection Recommended *****

Item 10C: Vinyl flooring behind the washer area in the utility room is loose. However underlayment below that area does appear firm. We noted no signs of infestation in the subfloor below. We would however if requested perform additional inspections after the appliances have been removed.
 ***** Unknown Further Inspection Recommended *****

Item 11B: Along the left and rear of the dwelling ivy is growing next to and on to the structure. It is recommended that during the course of landscape maintenance that ivy be kept cut well back from the dwelling and void space maintained away from same.
 ***** This is a Section 2 Item *****

Item 11C: A pet access door has been installed in the rear garage door. Door surface is beginning to separate. Owner is advised to keep this opening sealed and maintained as part of maintenance. Estimate for a new door would be submitted if requested.
 ***** Information Item *****

RECOMMENDATION: Remove and dispose of all debris of a size large enough to be raked.
